COMET LAKE DAM

(NDI ID. No. PA-00796, Number  
PENNDER ID. No. 28-103) Number

PHASE I INSPECTION REPORT,  
NATIONAL DAM INSPECTION PROGRAM

(11) AUG 1980

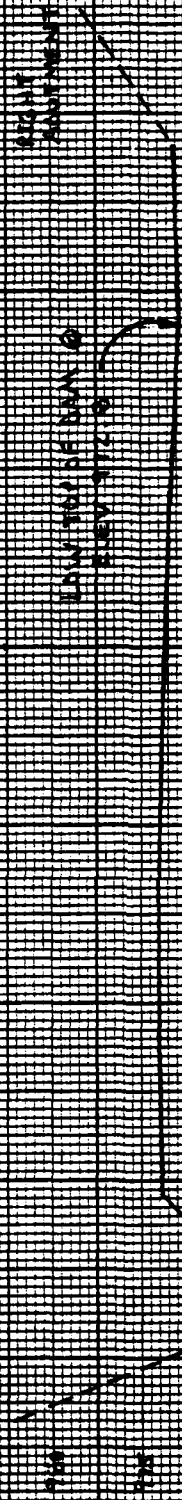
PROFILE OF DAM CREST  
FROM FIELD SURVEY

b. Embankment. Observations made during the visual inspection indicate the embankment is in fair condition. No evidence of sloughing, erosion, seepage through the embankment face, or animal burrows were observed. The embankment slopes are heavily overgrown with thick brush indicating a lack of regular, routine maintenance (see Photographs 1, 3 and 4). Two distinct swampy areas were observed as indicated on the field sketch (see "General Plan, Field Inspection Notes", Appendix A). Both swampy areas are located beyond the limits of the downstream embankment toe (see Photograph 8). No measurable seepage flow was observed. The embankment crest is well protected with a cover of asphalt paving; however, field measurements indicate differential settlements in excess of 1-foot (see "Profile of Dam Crest", Appendix A).

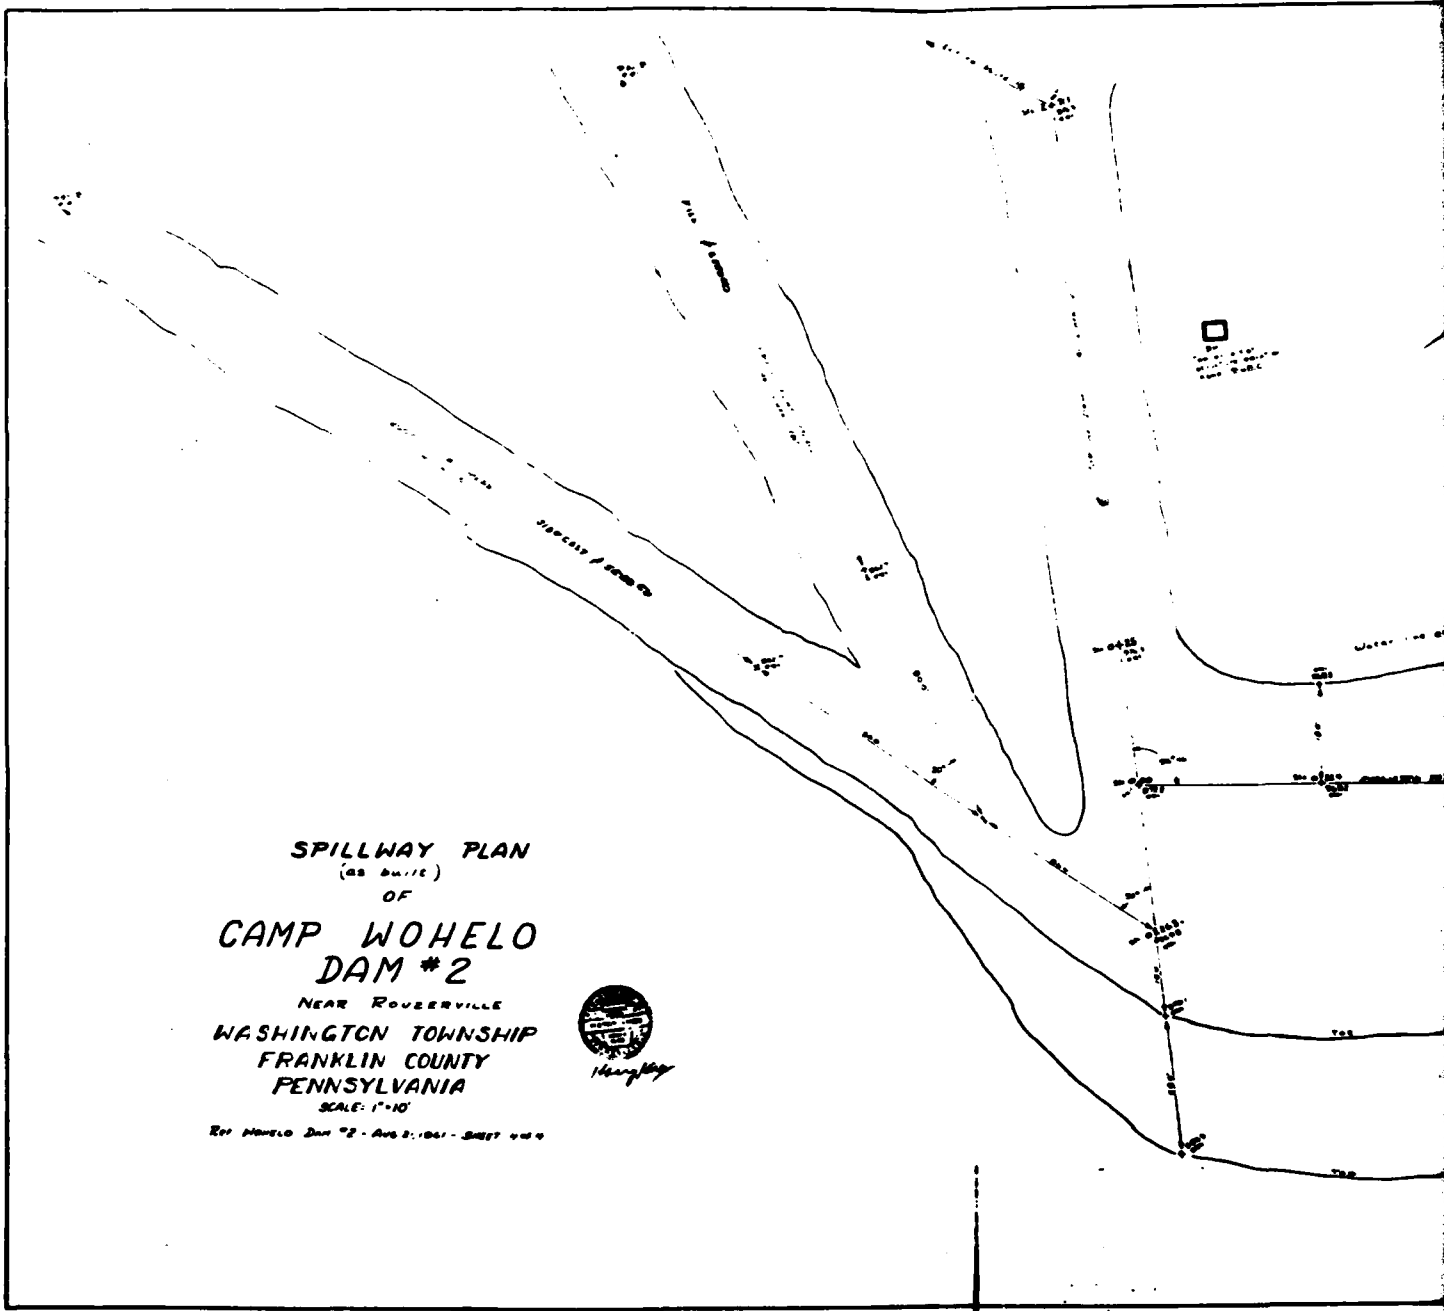
SPILLWAY PLAN  
(AS BUILT)  
OF  
CAMP WOHELO  
DAM #2  
NEAR ROUSEVILLE  
WASHINGTON TOWNSHIP  
FRANKLIN COUNTY  
PENNSYLVANIA  
SCALE: 1"=10'

b) Emergency Spillway. The emergency spillway is an uncontrolled, trapezoidal shaped, rock cut channel located at the left abutment. Discharge is dictated by critical depth at the control section with no regulating weir (see Figure 5). The original design drawings required a concrete control section that was never constructed (see Figure 4). The spillway section downstream of the control is poorly defined with a right sidewall locally less than 1-foot high. This may be attributable to the fact that the emergency spillway also functions as a service road to the lower toe area and that some regrading may have been done within the channel to accommodate vehicular use.
